2nd International Conference on Structural Integrity, ICSI 2017, 4-7 September 2017, Funchal, Madeira, Portugal

Non-Destructive Structural Wood Diagnosis of a Medieval Building

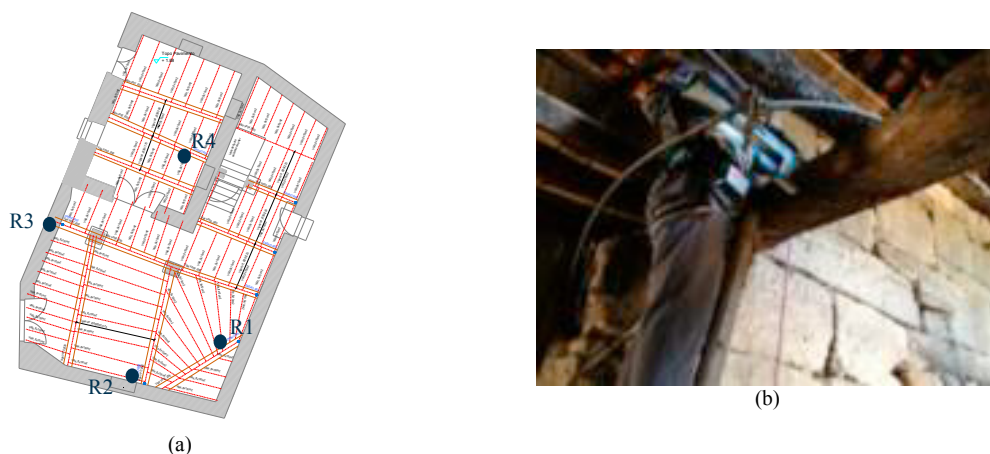
already inspected with the use of hammer. A total of 4 tests were carried out with this apparatus, in the locations presented in Fig. 2 (a) along the floor beams. The results show that exists in some cases surface degradations and internal degradations of the wood. In Fig. 2 (b) is showed the example of a test in a beam. In the Fig. 3 to Fig. 6 are presented the resistograph graphics obtained for the 4 pavement beams tested.

Fig. 2. (a) Location of the points where the tests were carried out with the resistograph; (b) Structural plant of ground floor; (b) Resistograph testing (images from: [9]).

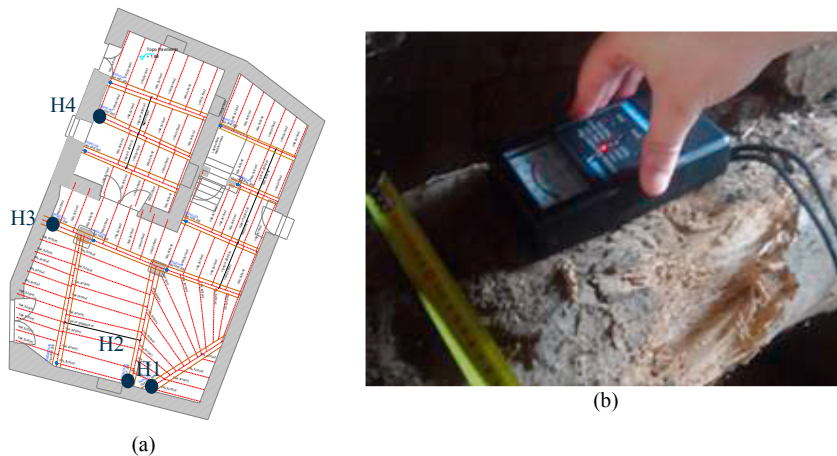
In Fig. 8 (a) are presented the inspection with humidimeter sites. In Fig. 8 (b) is showed an example of the evaluation of the humidity content of a beam with the humidimeter. Were tested 4 beams, recording the section diameter, conservation state, obtained by visual inspection in the supports and the water content. The information obtained through visual inspection was classified as: good, degraded and reasonable scale. The areas of the pavement more

exposed to rain, had a higher humidity content. The humidimeter readings were compared with the resistograph results for the correspondent elements. In Table 1 are presented the results obtained in this test, and it's possible to observe that the H3 spot has a higher humidity content (14%), and the lower value occurs in the H1 spot.

Designation	Mean Section, Ø (cm)	Actual state	Left support	Right support	Humidity content (%)	Visual observation
H1	35	Reasonable	Good	Degraded	12	Cracks and Nodes
H2	32	Degraded	Degraded	Degraded	13	Node at ½ span
H3	30	Degraded	Degraded	Good	14	Crack
H4	30	Reasonable	Reasonable	Good	13	Node

Fig. 8. Structural plant of the ground floor with the identification of the inspection sites (images from: [9]).
