2nd International Conference on Structural Integrity, ICSI 2017, 4-7 September 2017, Funchal, Madeira, Portugal

Structural Characterization of 13th Century Building placed in Trás-os-Montes Region

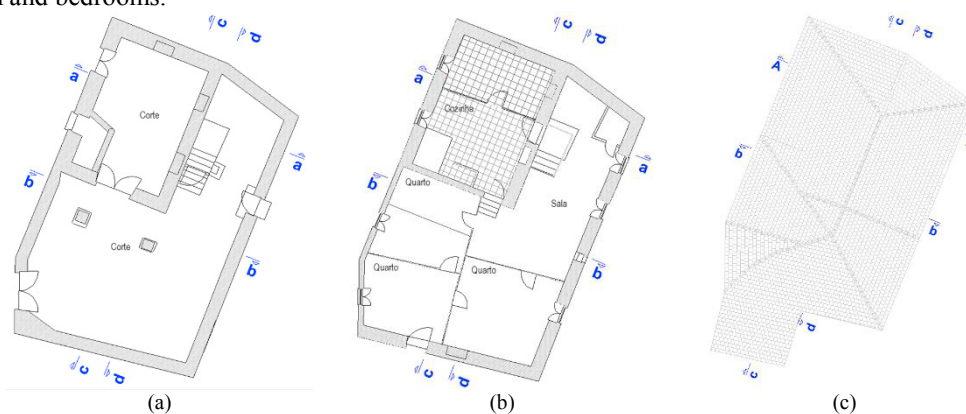
Fig. 1. Architectural survey of the building: (a) basement plant; (b) first floor plant; (c) roof plant (Images from: [7]).

The case-study building has a medieval based architecture, which gives grate value to it. It's composed by Inn and the cereals storage buildings in the surroundings. In Fig. 1 are presented the plants of the two floors of the building and the roof and in Fig. 2 the cuts of the building. The building is made with stone masonry walls and wood roof structure covered with ceramic tile. The building has a rectangular plant, with external access made by stairs in stone. In terms of interior spatial organization, in the basement, were the storage rooms and on the first floor, the kitchen, living room and bedrooms.

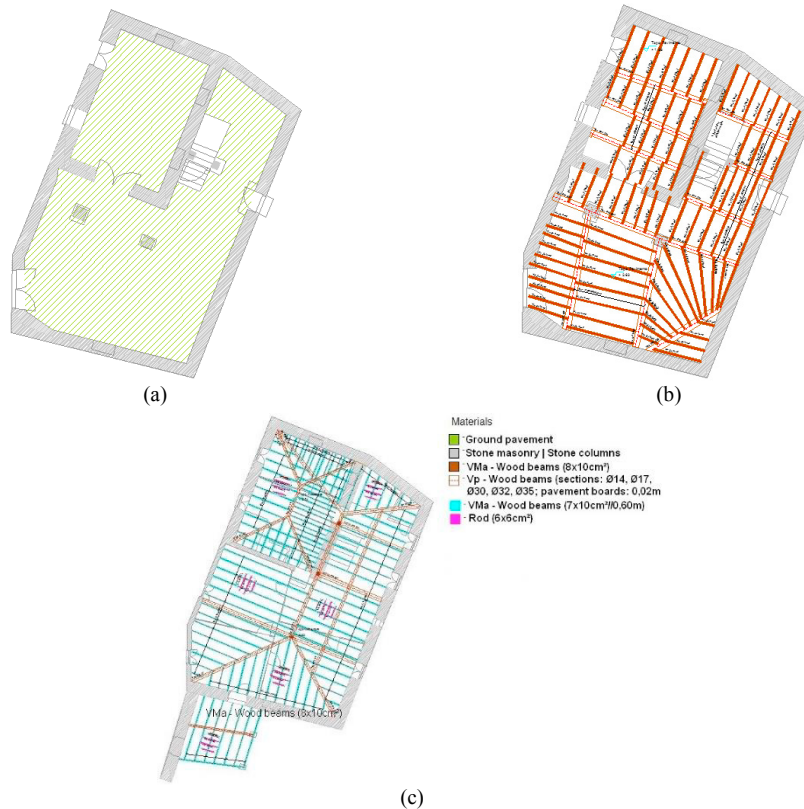
Fig. 3. Structural plants: (a) basement; (b) first floor; (c) roof (images adapted from: [7]).

A complete structural characterization requires to have the original structure design, and if it is the case, the records of the interventions that occurred. It's necessary to know the structural materials properties. The visual inspection should be complemented with those designs to do a critical analysis of the observed damages in the behaviour of the structural elements. In Fig. 3 are presented the structural plants of the basement, first floor and roof.

The building masonry walls (Fig. 3) are supported by masonry foundations. The pavements between floors and roof structure unload in the exterior masonry walls. In the ground floor, in exists masonry walls basement (Fig. 3 (a)), which are supported by the ground. The wood partition walls of the first floor (Fig. 3 (b)) unload in the floor between ground and first floor.

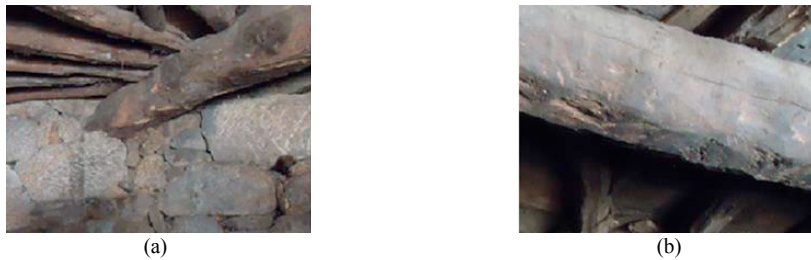
Fig. 5. Wooden beams supported by masonry walls (images from: [7]).

The division between floors is made with wood (chestnut) structures, composed by a truss of wood, made with grated sticks, with diameters between 0.14 and 0.35m and lengths that depend on the spans between walls of the house, not exceeding 7 m. The rolled sticks are supported in the two extremities by the masonry walls, with a delivery of about 2/3 of the thickness of the walls, and sometimes in all their thickness, and sustenance the floor and ceiling coverings. In some cases, flanks with four faces may be used in the walls. To protection of the beams was made by painting it with oil paint, red lead or tar, after their placement [8]. The rolled beams are parallel to each other, with spacing between 50 to 70 cm. Fig. 5 presents some examples of the pavement structures of the building.
